Manhole Inspection Summary

Manhole # S21GG1013MH

Location Address: **I-83**

Cross Street: **41ST ST**

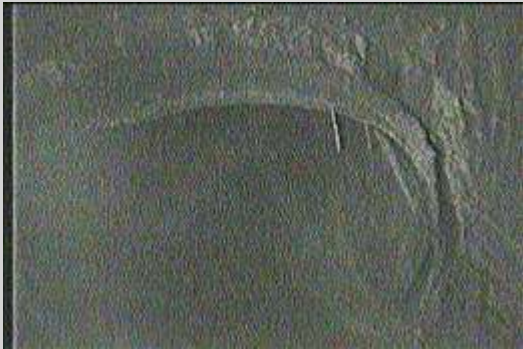
60 in. Circular Gravity Sewer Pipe Out @ 12 O'Clock

Invert Depth: **22.30** (ft.) Flow Characteristics: **Turbulent**

Deposits: ☒ None ☐ Mud ☐ Sludge ☐ Debris ☐ Grease

Infiltration: **None** Pipe Seal Cond: **Unknown**

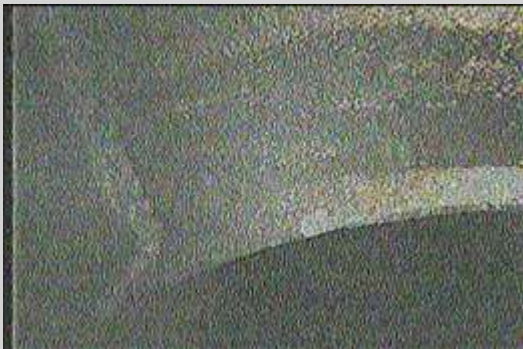
48 in. Circular Gravity Sewer Pipe In @ 6 O'Clock

Invert Depth: **22.00** (ft.) Flow Characteristics: **Turbulent**

Deposits: ☒ None ☐ Mud ☐ Sludge ☐ Debris ☐ Grease

Infiltration: **None** Pipe Seal Cond: **Unknown**
